Technical Service Bulletin

No. D67-19-4

Steering
Column Horn
Ground Clip

MODELS: 1967
Dart, Coronet,
Polara, Monaco
and Charger
Equipped With
non-Adjustable
Steering Wheel
Built Before
March 15, 1967

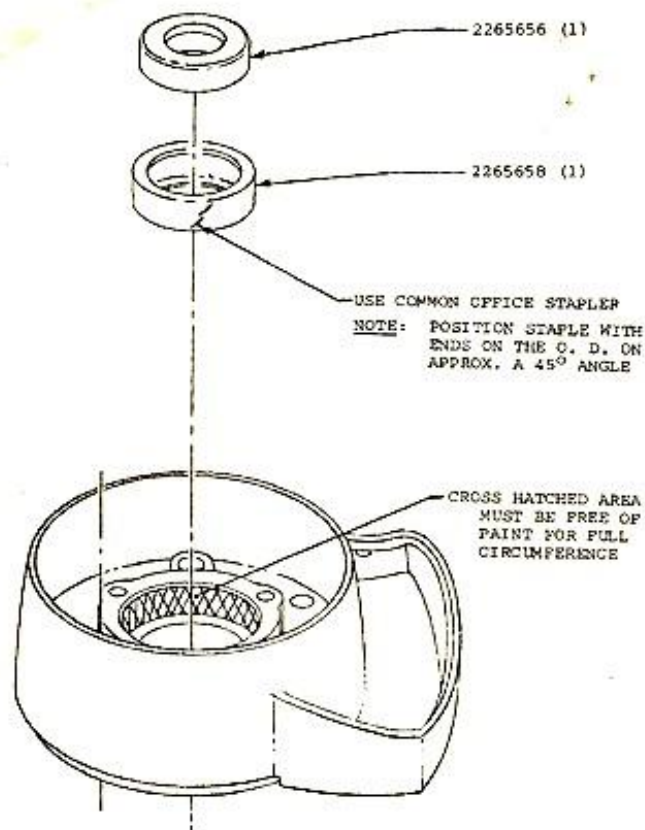
If you should encounter a condition of a scraping noise within the steering column on the subject models it may be caused by the steering shaft ground clip rubbing on the shift tube.

Figure 1 and install one (1) staple in the upper steering column bearing insulator as shown in sketch. Following the re-assembly and installation of the steering column provide an alternate ground path by installing a wire as shown in Figure 2.
